SPIRIT OF SUTTERBY PROJECT
Report on an Archaeological Excavation at Sutterby Church
23rd - 30th May 2015

APPENDICES

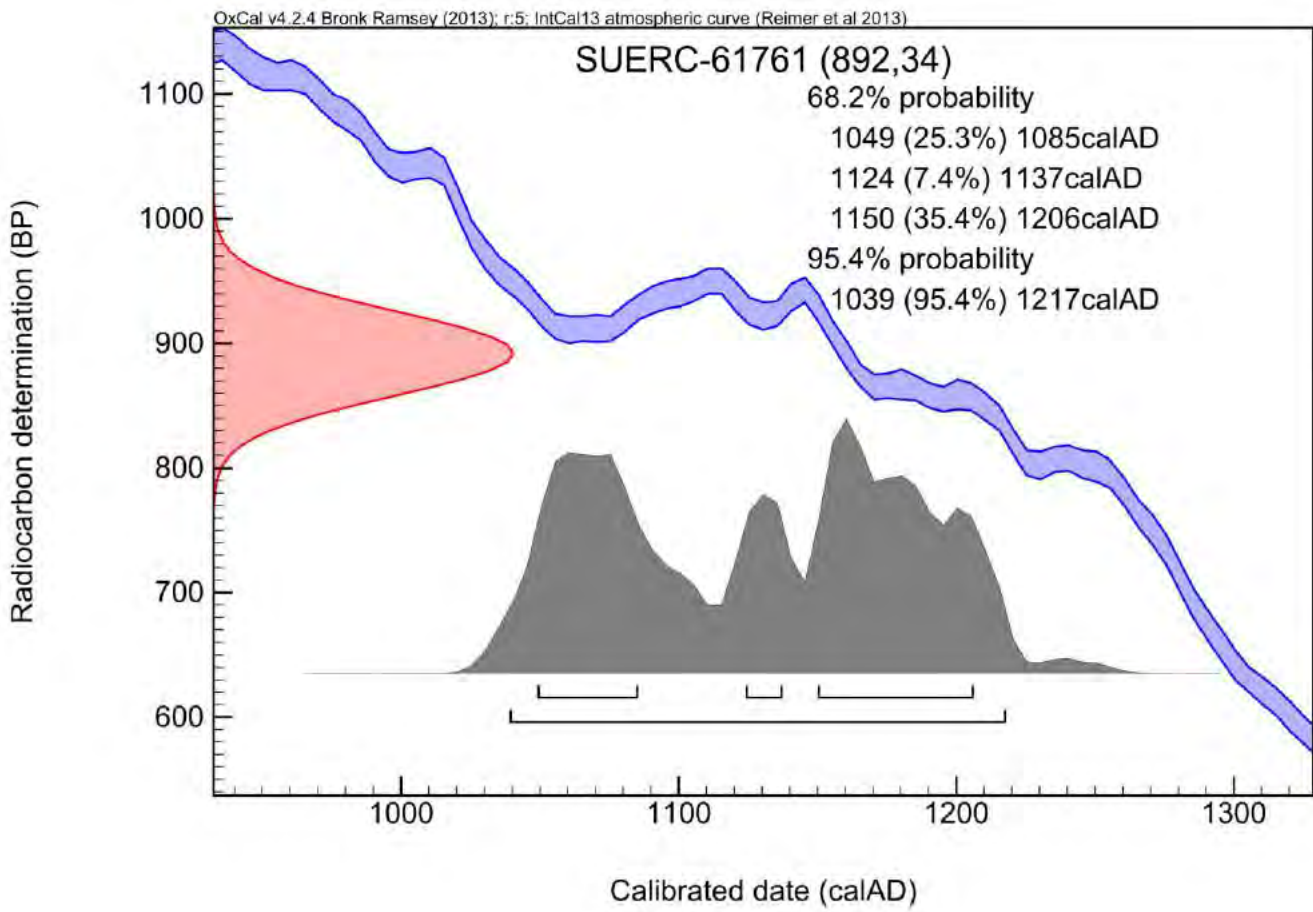
Calibration Plot

Laboratory Code	SUERC-61761 (GU38209)
Submitter	David Start Spirit of Sutterby Project The Rise, Valley Lane Swaby Alford Lincs LN13 0BH
Site Reference	SUTTERBY (SUT15)
Context Reference	SUT 15 050
Sample Reference	SUT15 055
Material	Human : Femur
$\delta^{13}\text{C}$ relative to VPDB	-20.3 ‰
$\delta^{15}\text{N}$ relative to air	9.7 ‰
C/N ratio (Molar)	3.2
Radiocarbon Age BP	892 \pm 34

The calibrated age ranges are determined from the University of Oxford Radiocarbon Accelerator Unit calibration program (OxCal4).

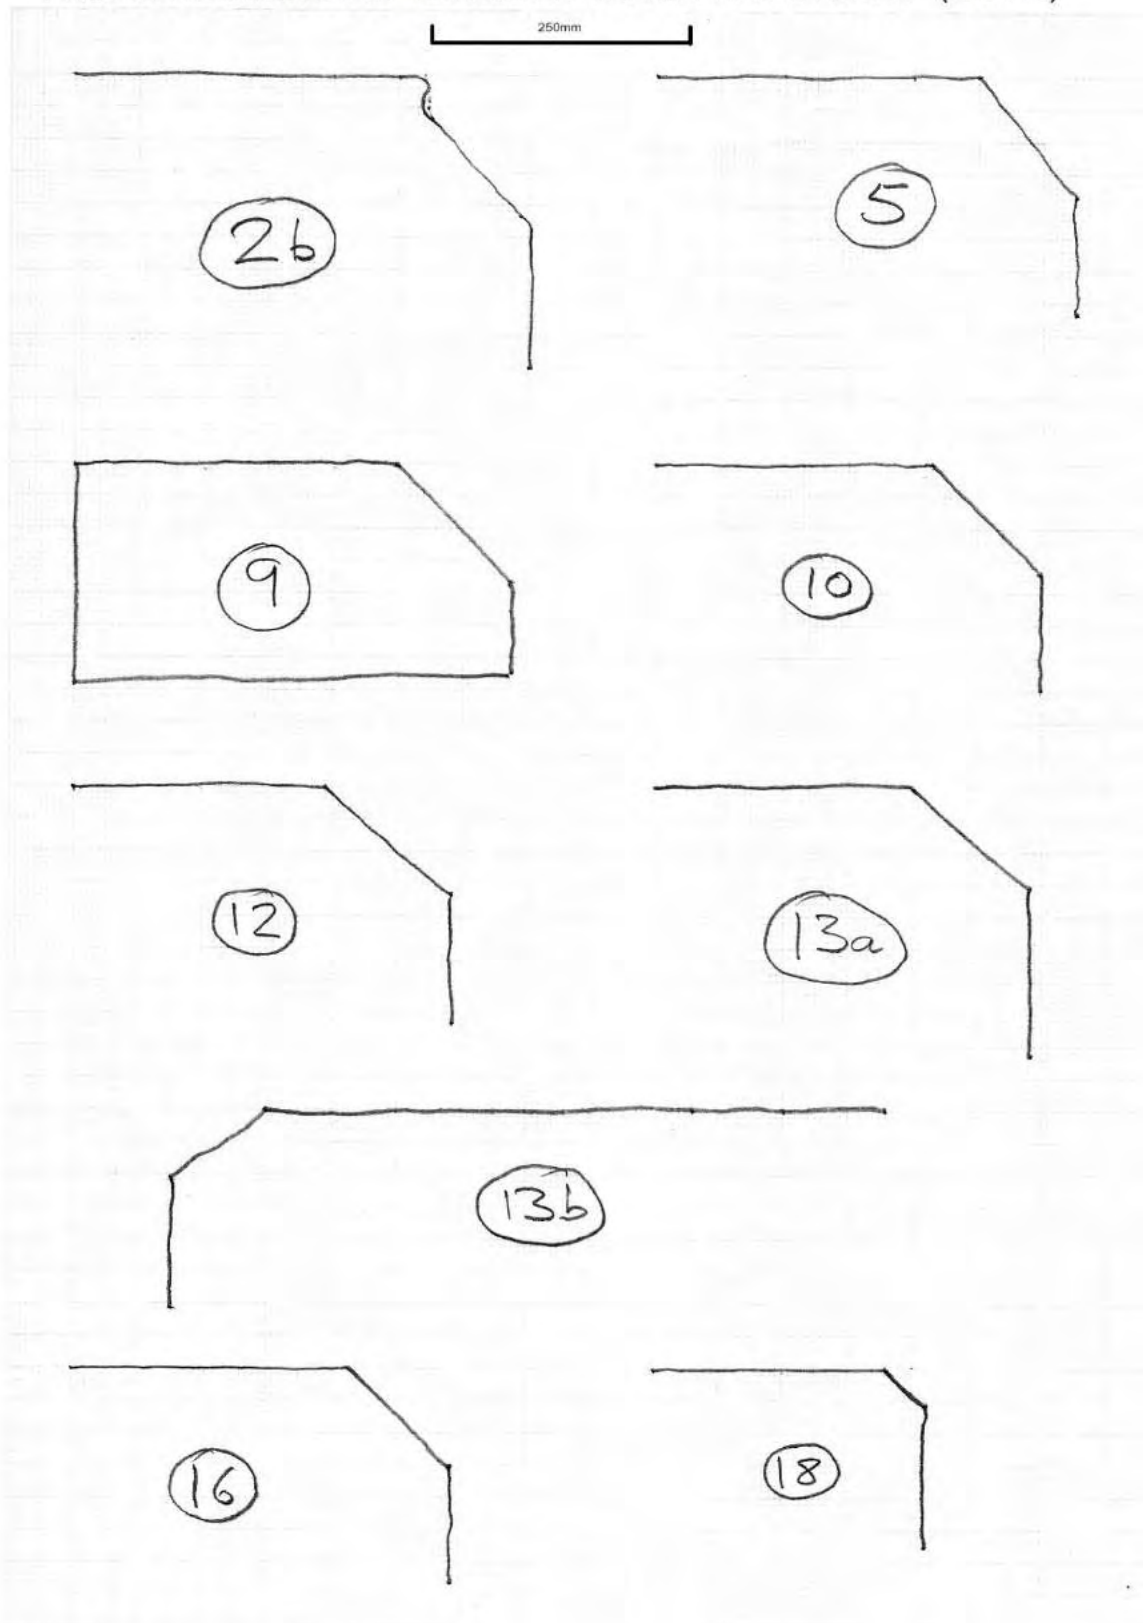
PROFILE DRAWINGS OF SELECTED CHAMFERED STONES (SUT15)

Corner stone 2a/2b is not a simple chamfer - it has two elements - a sort of short hollowing and then the chamfer (see profile drawing)

Stone No	Angle °	Top (mm)	Chamfer (mm)	Side (mm)	Back (mm)
1	63				
2a	54				
2b	40	270	25/120	70	
3	53				
4	41				
5	40	251	120	90	
6	48				
7	59				
8	44				
9	45	250	125	70	175
10	45	215	120	90	
11	53				
12	49	195	128	100	
13a	50	200	120	65	
13b	53	480	90	100	
14	33				
15	*				
16	46	215	110	89	
17	41				
18	49	180	43	110	
19	no chamfer				
20	38				
21	38

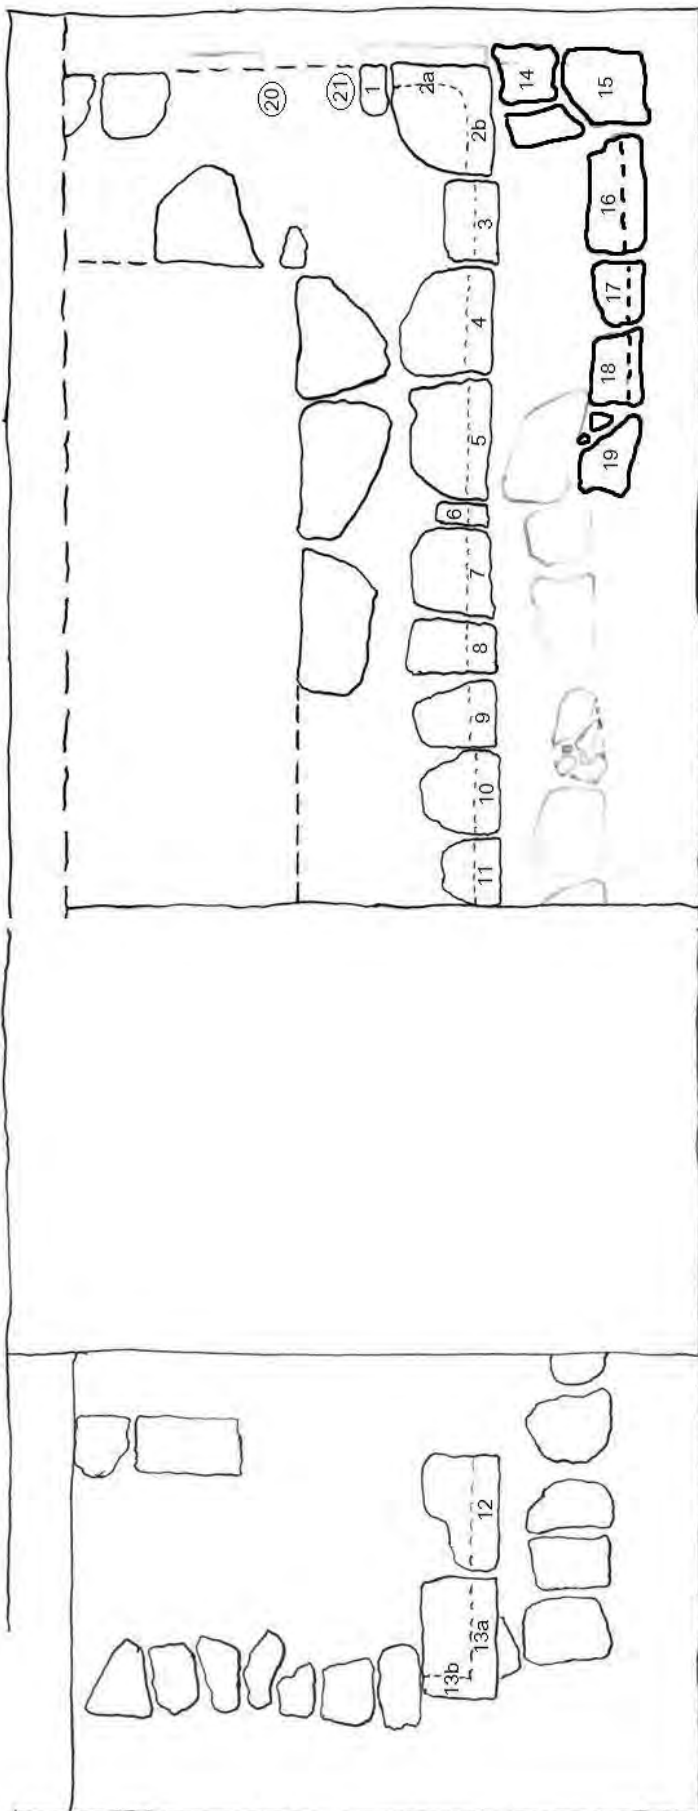
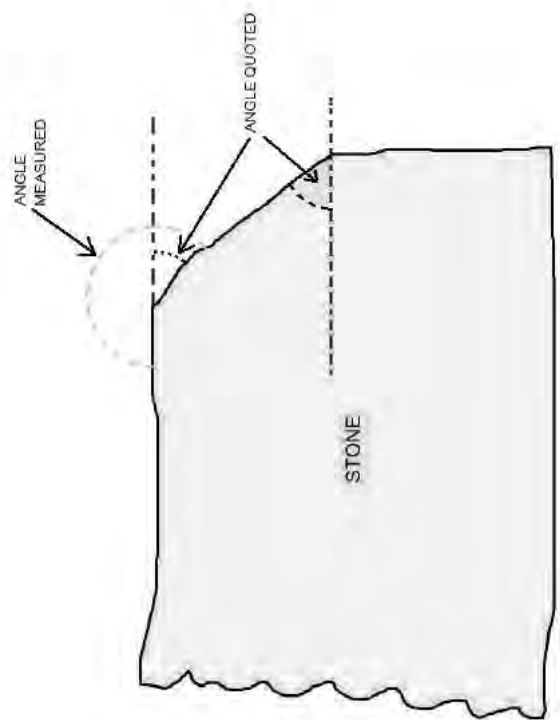
OUTLINE PLAN - KEY TO CHAMFERED STONES - SUTTERBY EXCAVATION (SUT15)

(See diagrams for key and identification numbers and definition of angle measured)

*Corner stone 15 is not really chamfered on either W or S face - it is virtually flat. It lines up with good chamfered stones and may have been chamfered once - it looks worn - is this from a footpath/pathway around corner of church?

16 has a really good chamfer - 17 is not a good chamfer on west face - there is possible chamfer on N face but it is not straight (DAS says not chamfer). 18 has a short chamfer. 19 has no chamfer.

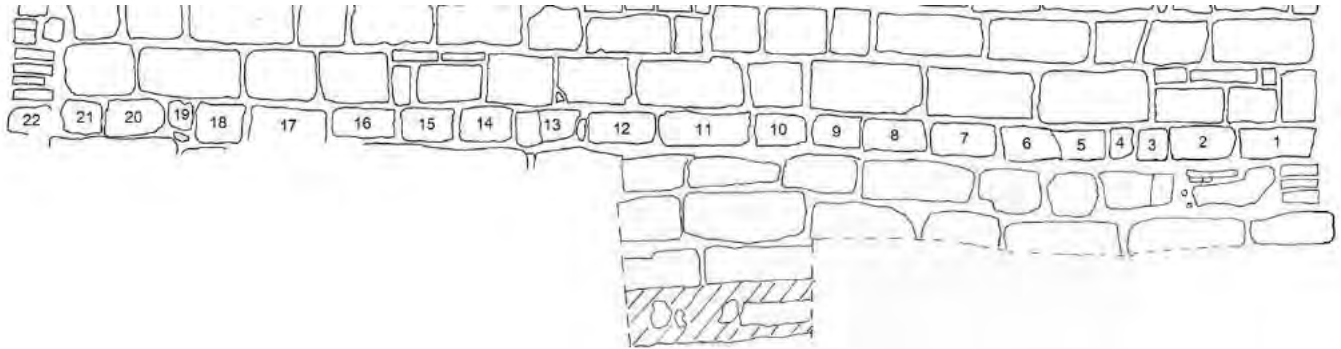
SUTTERBY CHURCH WEST WALL CHAMFER COURSE DESCRIPTION

N ^o .	Comment	cms	N ^o .	Comment	cms	N ^o .	Comment	cms
1	worn chamfer	5	9	quite good chamfer	8	17	good chamfer, long	9
2	worn chamfer	5	10	quite good chamfer	10	18	damaged chamfer	4
3	'dropped' worn chamfer	7.5	11	long; worn base	9	19	damaged - no chamfer	-
4	very worn chamfer	4	12	good chamfer - worn below	10	20	damaged chamfer; scored	7
5	all one stone worn	9	13	Fragmentary - poss worn chamfer		21	damaged chamfer - scored	7
6			14	quite good chamfer	8	22	damaged, fragmentary. Prob once chamfered	-
7	good chamfer	7	15	good chamfer	8			
8	good chamfer	8	16	good chamfer, base worn	6

The measurement shown (cms) is the projection of the chamfer from the wall above (i.e. the amount the lower courses project beyond the upper courses)

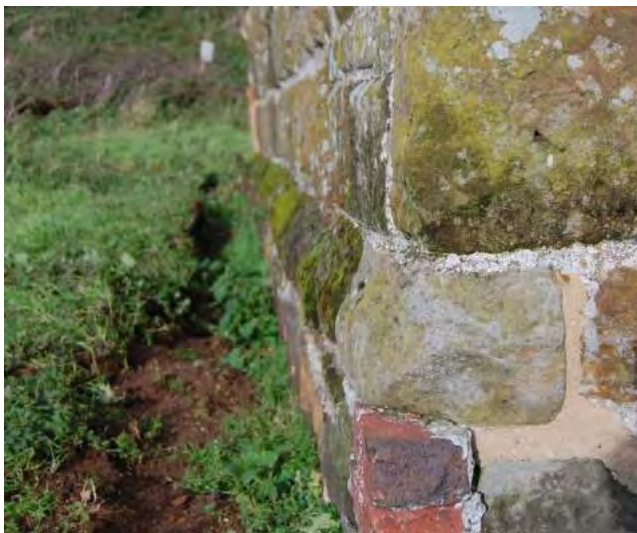
Photograph of the chamfered course viewed from SW corner of church, looking north (moss covered course).

The chamfer course is much worn. It has an average projection of 7.5 cms. The chamfer angle is worn and variable but averages c. 50°

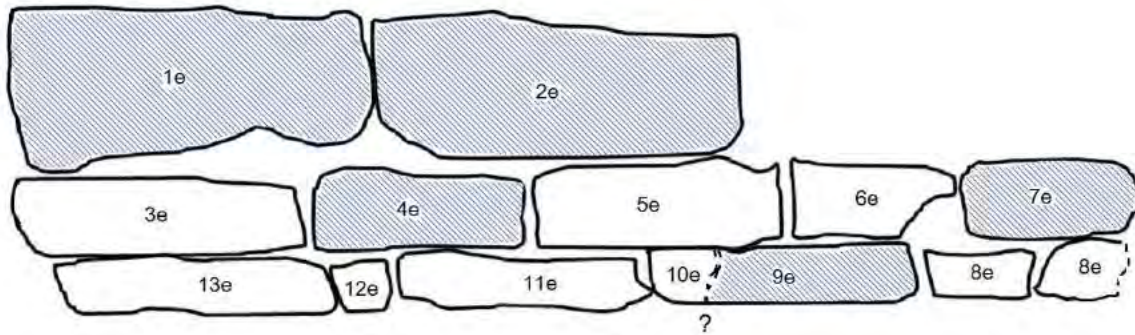
Sketch for identifying stones on east face of west wall
 For stone tooling analysis
 Shaded stones are discussed in the Table

Stone No.	Phase	Comments
1	4	weathering marks - not tooling
2	4	Tooling visible on top of stone - dressed with unornamented blade. Poss pre 13th C.
5	4	Dressed with a toothed blade of considerable size - A claw with very broad teeth and narrow gaps. Also another type of tooling on this stone with a different tool (unornamented). ?12th C block retooled in 13th C.
6	4	The cornerstone - tool marks visible in the square cut recess - made by a narrow bladed mason's point or punch. This is how the recess was created. Not readily datable. The recess is probably relevant to the secondary use of this stone. Possibly <i>cut in situ</i> .
7	4	Chamfered corner stone - Some tooling visible on top surface - big claw tool again (? same tool)
9	4	possibly some tooling on top surface
10	4	Possibly some tooling on top surface
20	2	Unornamented blade dressing. Might have two 'sockets' on it ... or could just be geology

23	2	Dressed in two directions with unornamented blade but not a broach dressing (not Roman). Better worked than 20. Only seeing top face - not display face. Not a claw (earliest claw dressing in Lincs is 1180 in St Hugh's choir)
25	3	Slight tooling on the top. Isolated shaping blows visible on the back
39	4	Some tooling with unornamented blade visible on the top. Block is crude and badly laid out - might even have been shaped/reshaped <i>in situ</i> . ?reworked
40	4	good unornamented tooling visible on top. No claw.
1e	4	well preserved, crisp tooling. Untoothed broad blade either side of central line giving herring bone pattern - worked from both sides of the banker
2e	4	As above, herring bone pattern with big unornamented blade used both sides of the banker
4e	4	As above with herringbone pattern. One side better worked than the other.
7e	4	May have scribed line separating better dressing from cruder dressing? Crude herringbone on left

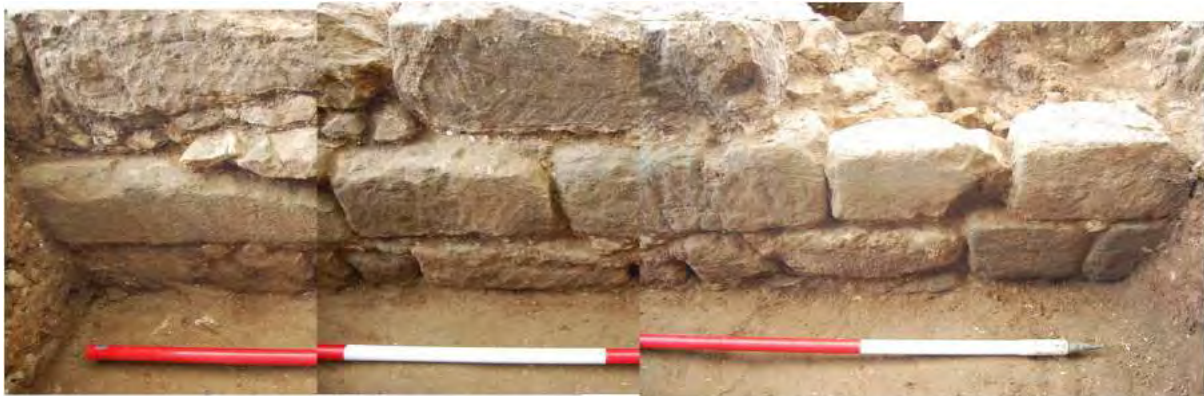
Photo-mosaic of stones on east face of west wall
 for stone tooling analysis

- Erosion of the soft sandstone has taken away most tooling from the display faces on external blocks. There is also a danger of later (and excavator) damage on the soft stone.
- There is very clearly the possibility of reused and reworked stones
- Most stones show a big bold blade (unornamented) without teeth.
- A group of stones have a big bold blade with teeth.
- This may represent two phases of buildings - one pre c.1200 and one post c.1200
- It would be useful to try to measure the tool blade widths visible on the photographs to pick out particular tool groups.
